## RYERSON STATION STATE PARK DAM

NDI I.D. NO: PA-193  
DER I.D. NO: 30-20

### PHASE I INSPECTION REPORT NATIONAL DAM INSPECTION PROGRAM

D'APPOLONIA CONSULTING ENGINEERS  
10 DUFF ROAD  
PITTSBURGH, PA. 15235  
MARCH 1979

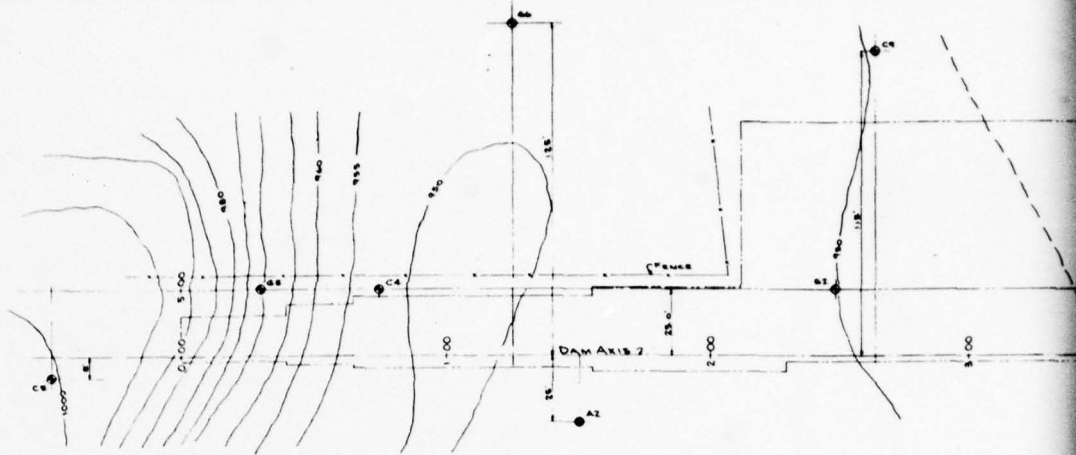
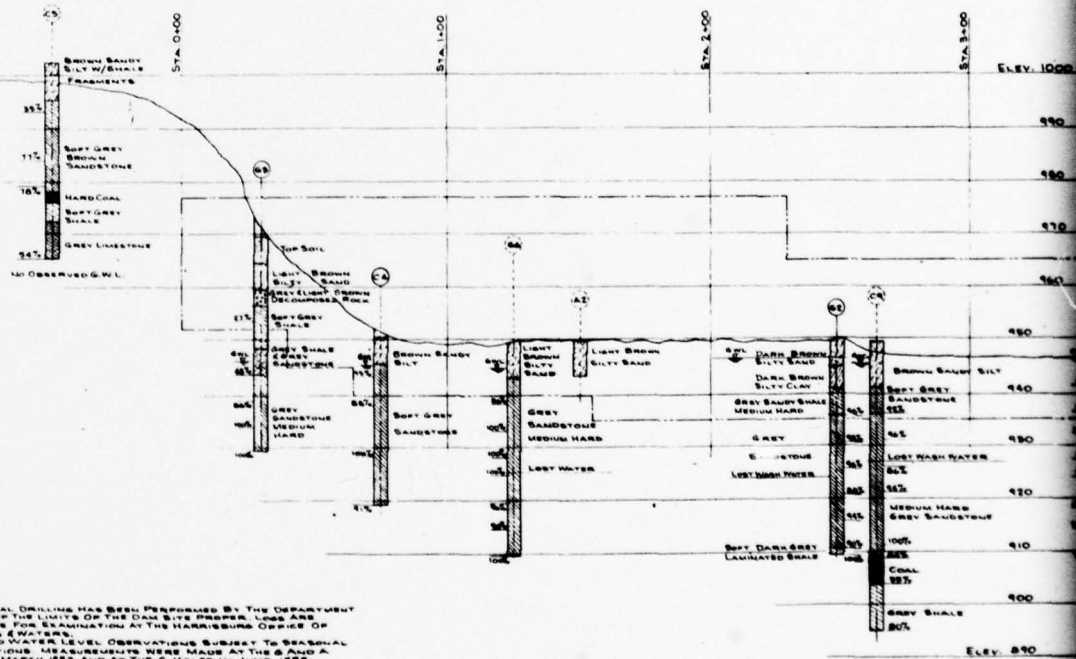
Plate 4 illustrates the typical subsurface profile at the dam site. At least nine borings were drilled to investigate the subsurface conditions. The rock beneath the site was predominantly classified as soft to hard gray sandstone. Calcareous claystone and shale layers were encountered on the abutments.

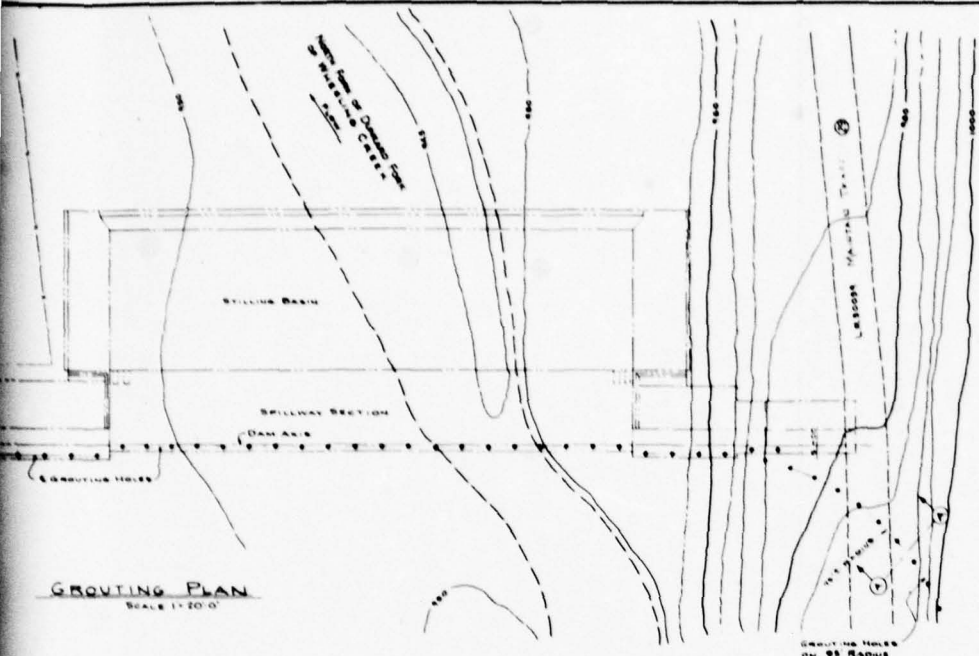
GROUTING PLAN  
SCALE 1"=20' 0"

The foundation rock was grouted through a single line of grout holes along the heel of the dam (Plate 5). Grouting was also performed on the abutments. Available information indicates that the grouting was performed in two stages. The first stage grouting was performed during foundation excavation prior to placement of concrete. The second stage of grouting was accomplished through holes drilled after at least 5 feet of concrete had been poured above the base of the dam.
